Renfrew Close Rain Gardens – Year two monitoring and project evaluation report, May 2017.

- This report presents results obtained from the second year of monitoring, covering the period of April 2015 – March 2017, and comments on the basin performance and lessons learned over the two years of the project.

- The research has been conducted over a two-year period by the Sustainability Research Institute at the University of East London (UEL) on behalf of the Environment Agency.

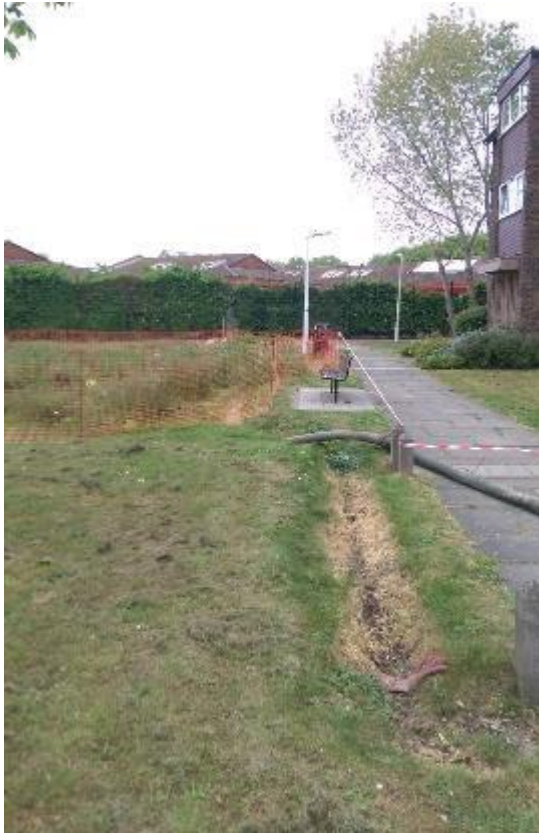
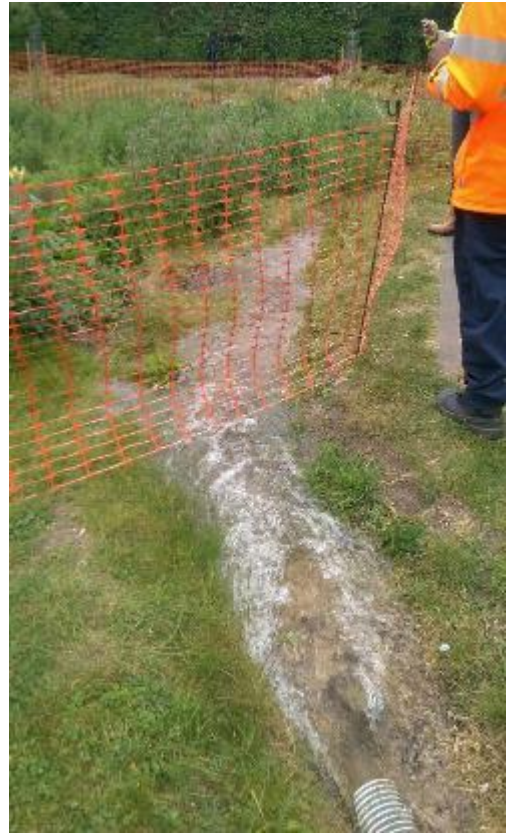
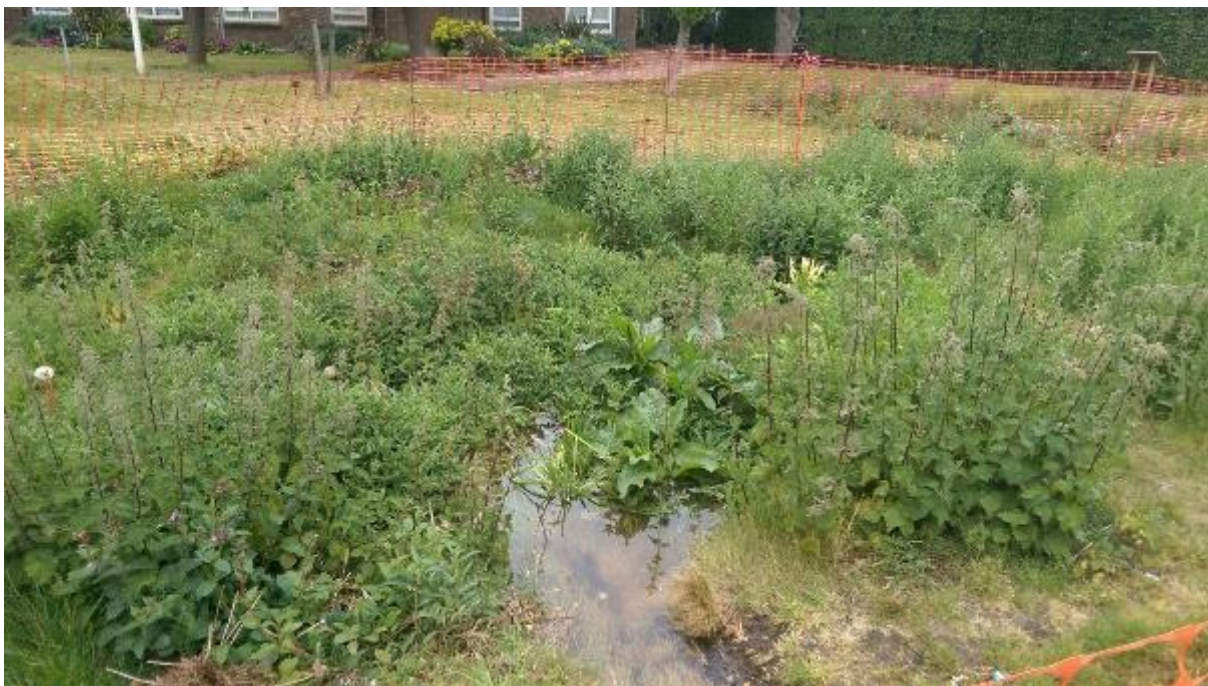
Figure 2: images from Basin 2 rainfall simulation. Top left– Tanker hose feeding into Basin 2, Top right, Water being poured into Basin 2, Bottom: Pooling surface water in Basin 2 at end of test.

During the testing, Basin 2 was tested first and received 6000L of water in one hour. This basin did not display any surface water pooling until around 3000L of water had been poured into the basin. This is highlighted in Figure 4, this pooled water reached a peak of 16cm deep after the final 1000L of water had been added which had fallen to 0cm after 38 minutes.

The depth of pooled water in Basin 2 was checked as often as possible whilst moving the tanker to Basin 4, so the actual time for the pooling to disappear is likely to have been shorter, for example following the last 1000l of water being added the pressure peaked at 0.14 Bar and took just 26 minutes to fall to 0 Bar (see Figure 4).

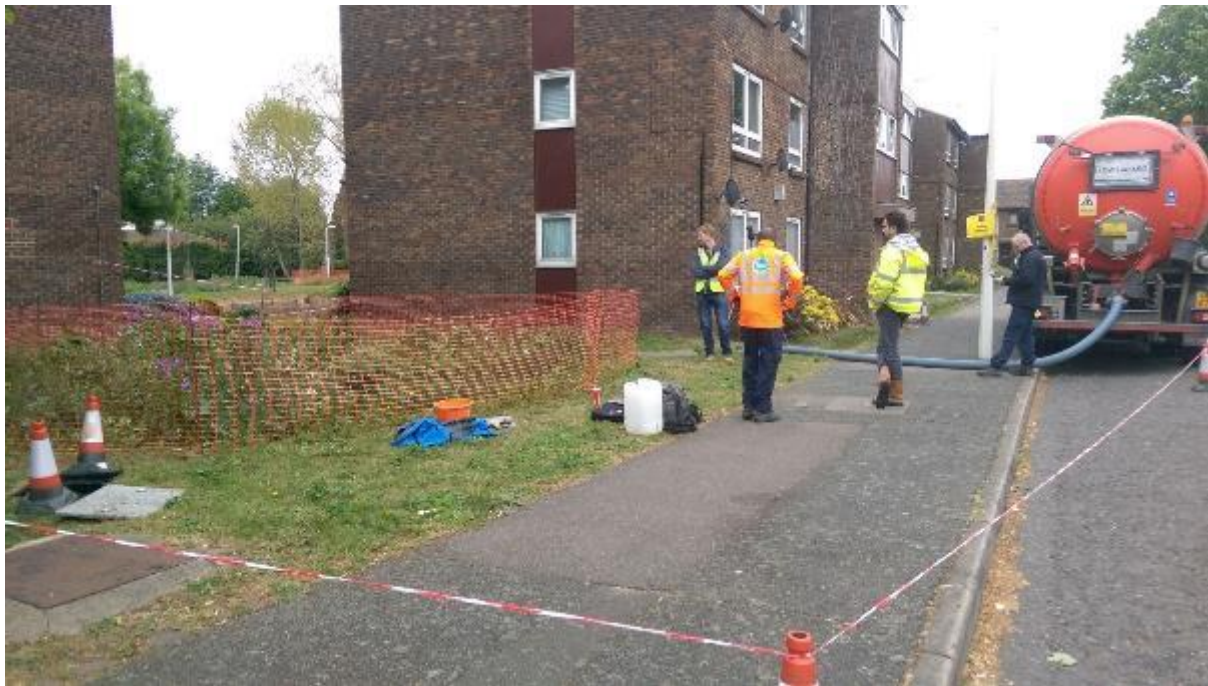
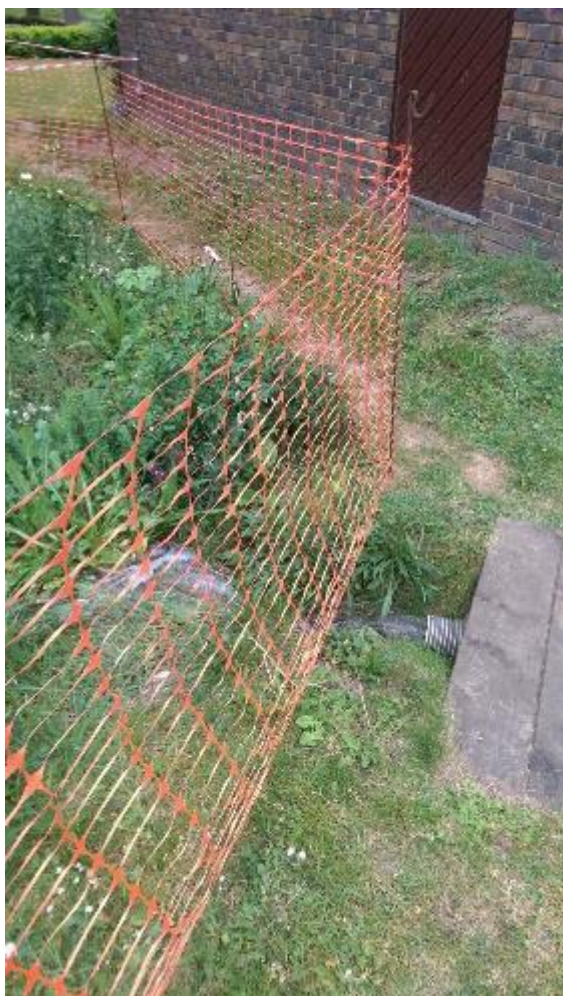
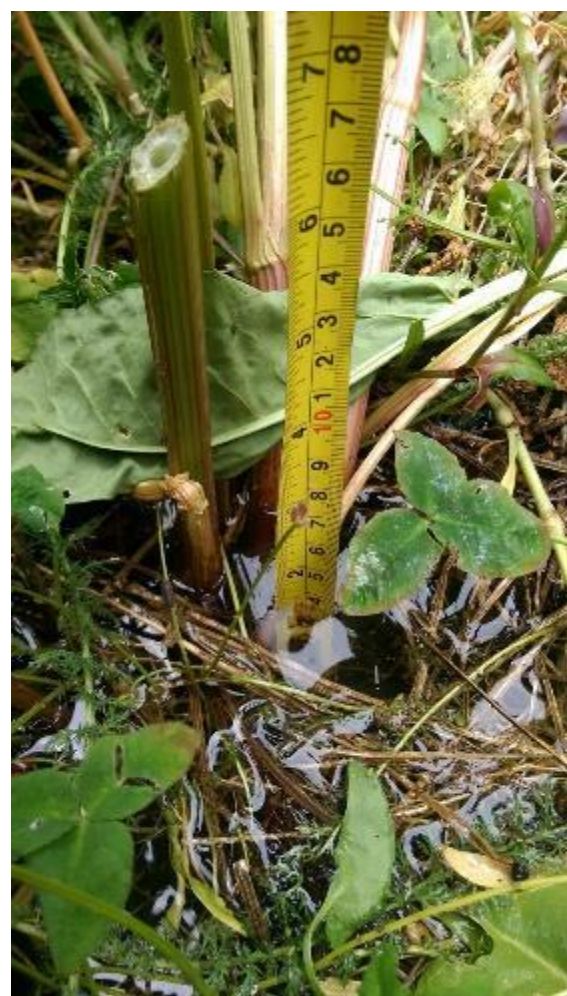
Figure 3: images from Basin 4 rainfall simulation. Top – set up showing tanker feeding hose into Basin 4, bottom left, water being poured into Basin 4, Bottom right, water pooling in Basin 4 at end of test.

Basin 4 was tested second and received 6000L of water in one hour. Like Basin 2 this basin did not display any surface water pooling until 3000L of water had been poured into it. Following the input of the final 1000L of final stage effluent water, the pooled water took just 11 minutes to infiltrate away. The pressure peaked at 0.25 Bar and took just 16 minutes to fall back to 0 Bar (see Figure 5). This faster infiltration time compared to Basin 2 is likely due to the larger surface area of Basin 4.
